FINAL REPORT
ON

EFFECT OF LAPPING PARAMETERS ON GENERATION OF DAMAGE ON
SILICON NITRIDE BALL SURFACES

U. S. NAVY CONTRACT NO. N00019-76-C-0147
S K F REPORT AL76TO26
S K F CODE LC050
S K F REG. 414 2

RESEARCH LABORATORY
SKF INDUSTRIES, INC.
ENGINEERING AND RESEARCH CENTER
KING OF PRUSSIA, PA.

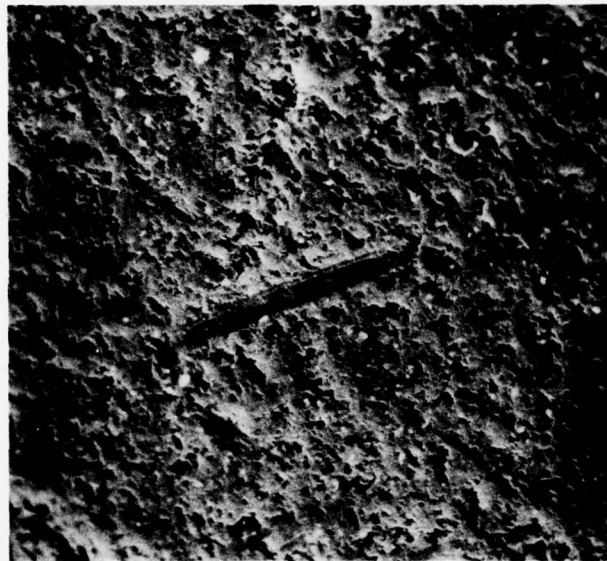
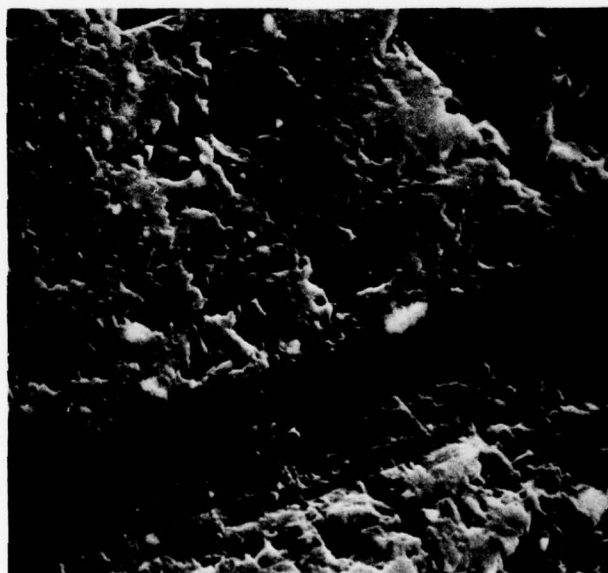
Figure 4. Surface Topography of Diamond Rough Lapped Balls

Abundant Slurry
44 N (10 lbs.)/Ball

A visual comparison of the surface topographies of SiC and diamond rough lapped balls, at 44N/ball load, is obtained by comparing scanning electron micrographs shown in Figures 3 and 4. The greater roughness of the SiC lapped balls compared to the diamond lapped balls is evident. This

is further illustrated by Talysurf traces shown in Figure 5. Close study of the 5000X photomicrographs reveals a difference in the mechanism of material removal by the two abrasives. Material removal by SiC appears to take place largely by a rubbing action producing a flat chip of the type indicated in Figure 3. The clean cutting action of the diamond abrasive, on the other hand, is evident from the surface scratch shown in Figure 4. Increasing the unit ball load does not cause a significant change in surface topography with either abrasive as evidenced by the relatively minor change in surface roughness (Table 2).

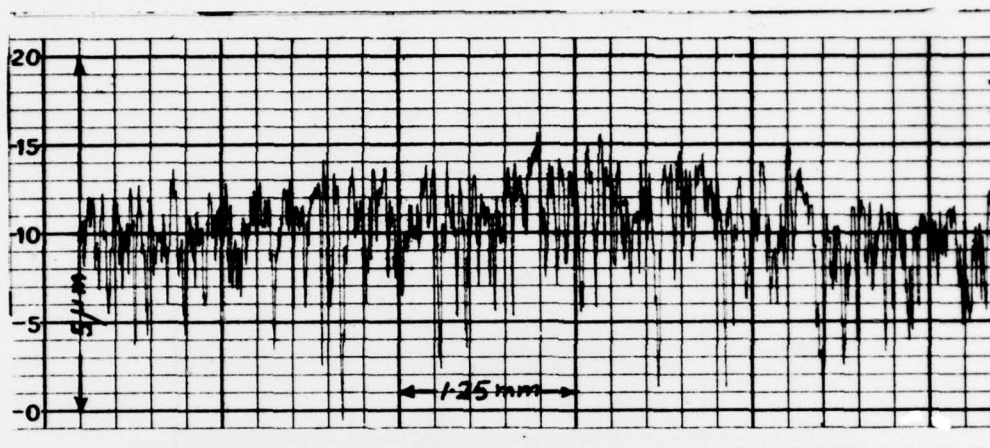
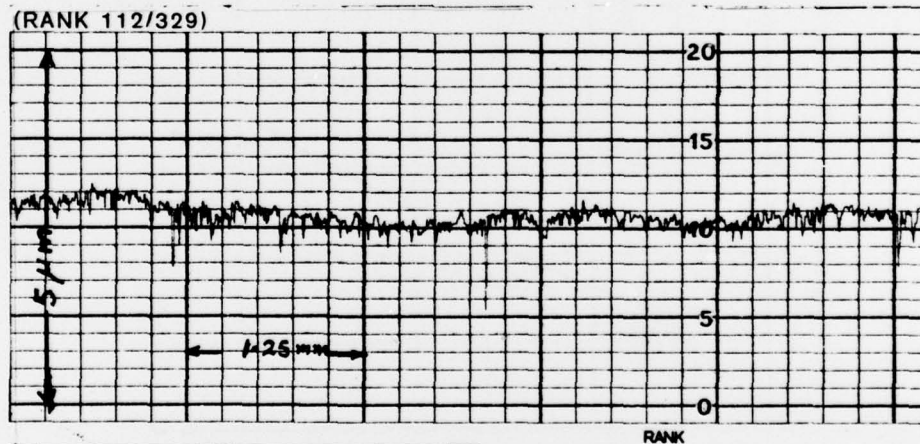
Figure 5. Talysurf Traces of Grade NC132 Silicon Nitride Ball
Rough Lapped at a Unit Ball Load of 44 Newtons
(10 lbs.)

a. Using 44 μm Grit SiC

b. Using 15 μm Grit Diamond

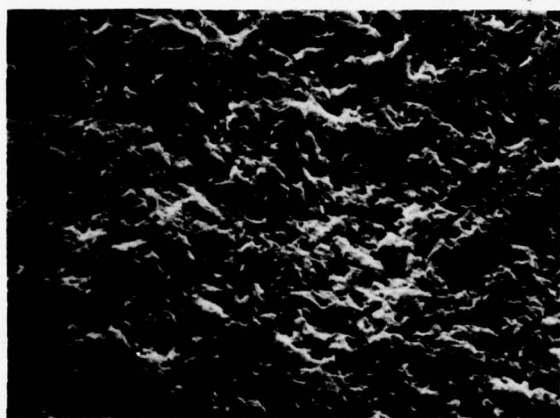
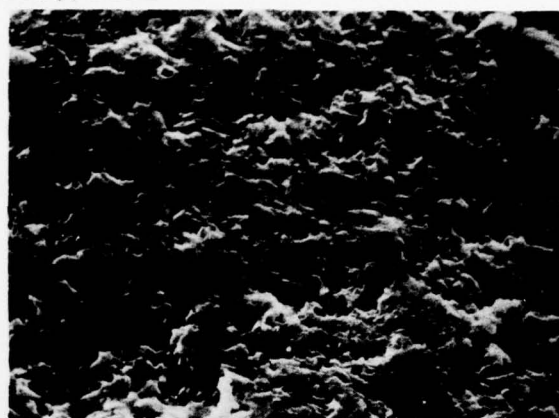
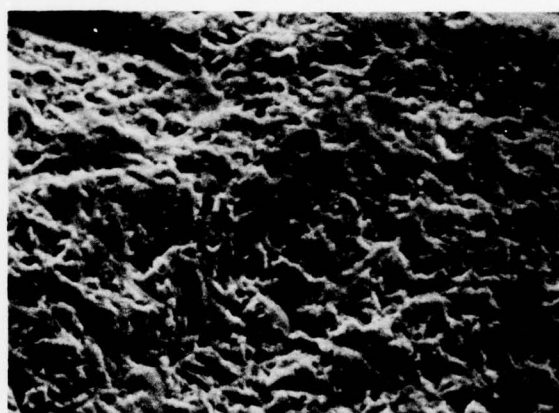
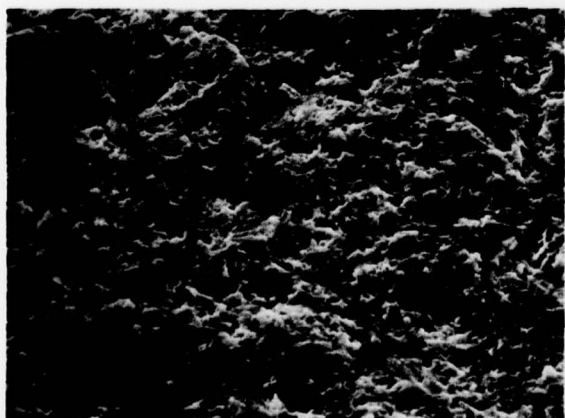
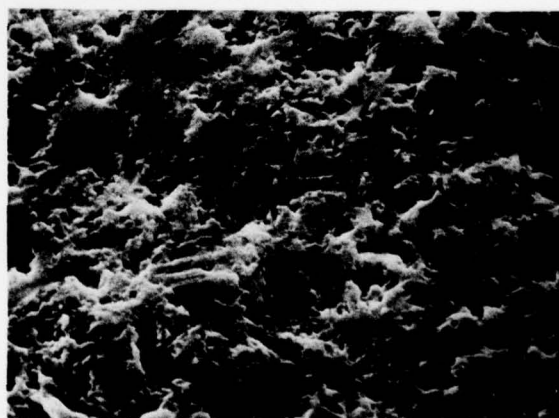
44 N (10 lbs)/ball

111 N (25 lbs)/ball

222 N (50 lbs)/ball

A visual comparison of the surface topography produced with increasing unit ball loads by the two abrasives is provided by the scanning electron micrographs in Figures 7 and 8.

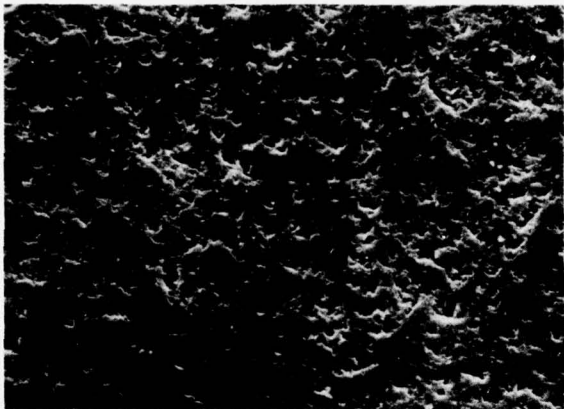
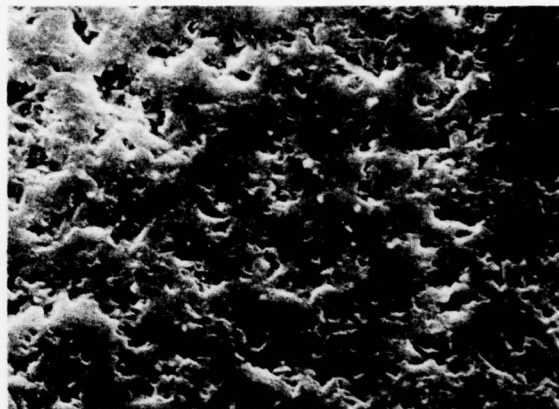
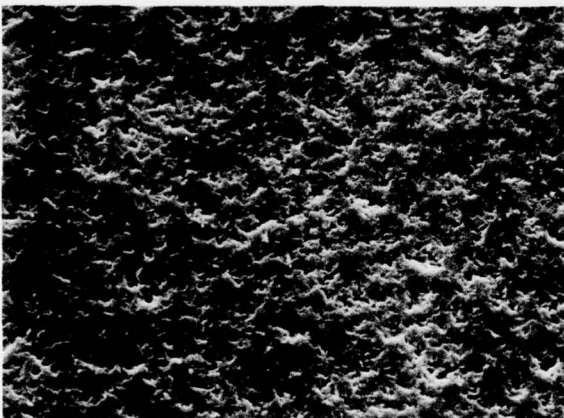
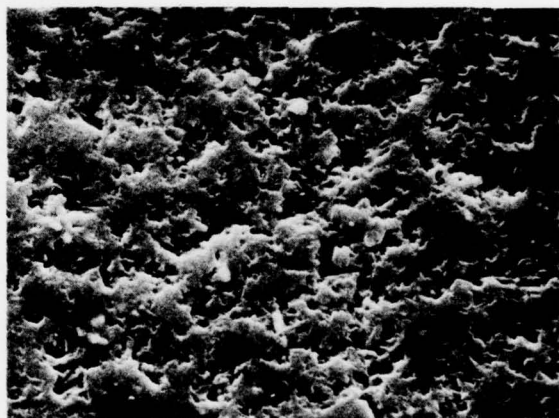
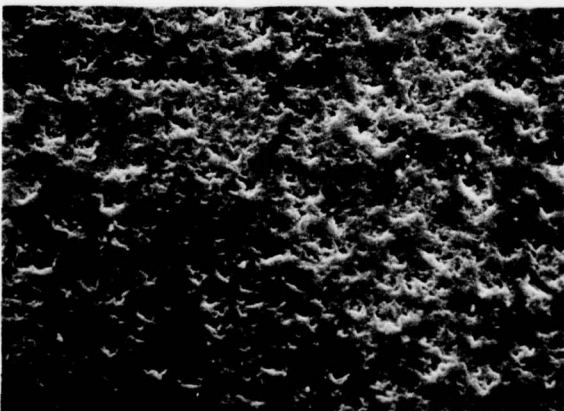
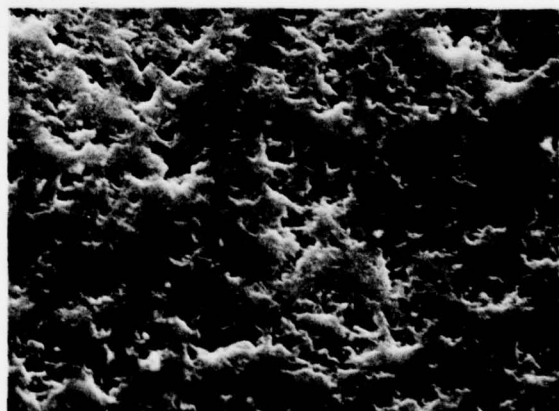
Figure 8. Surface Topography of Diamond Rough Lapped Balls
with Increasing Unit Ball Load Using Single Slurry Charge

44 N (10 lbs) / ball

111 N (25 lbs) / ball

222 N (50 lbs) / ball

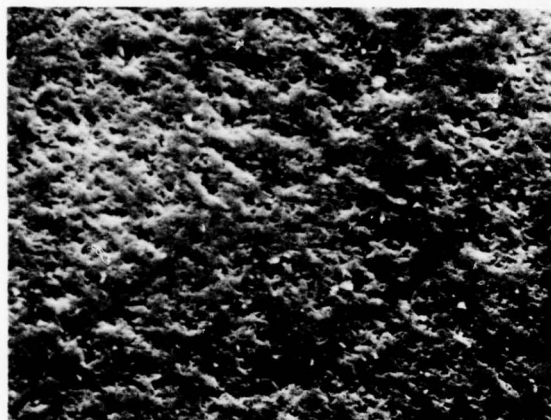
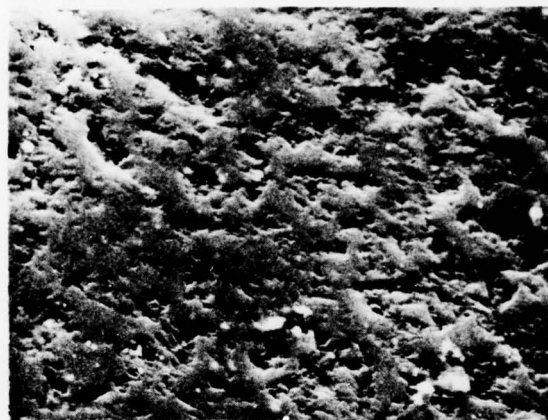
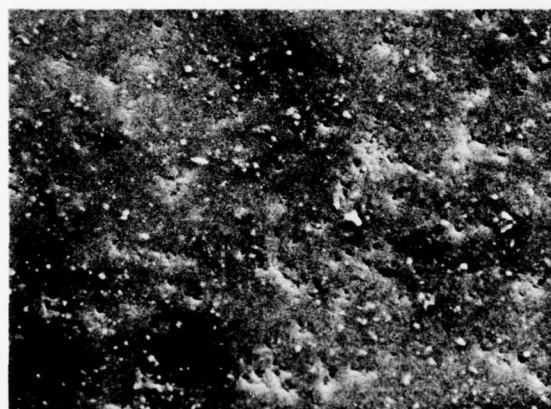
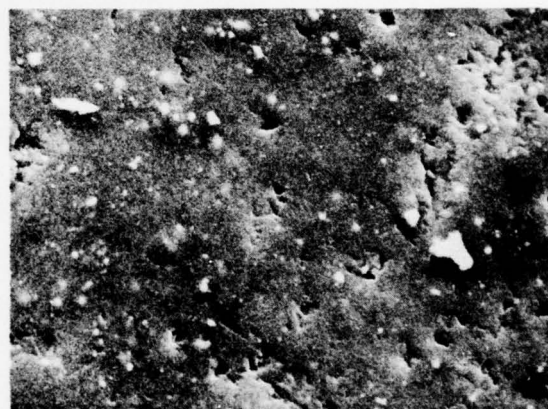
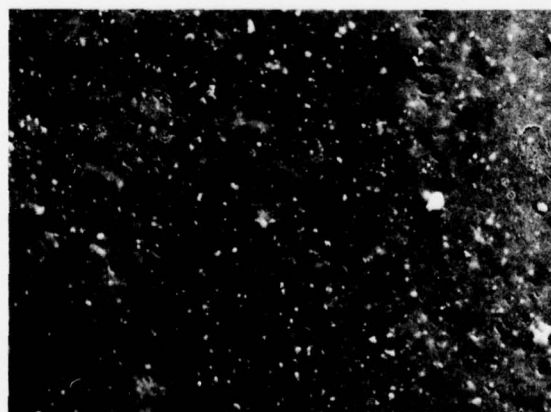
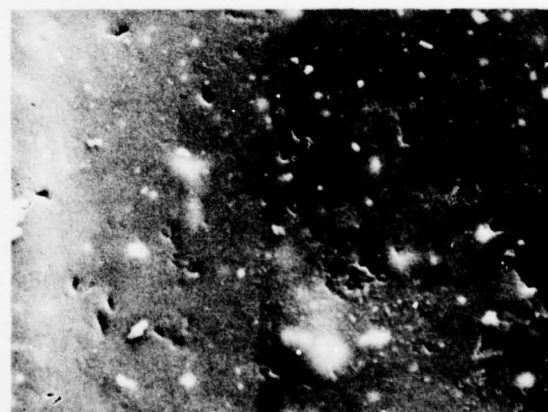
Figure 12. Surface Topography of Polished Diamond Rough Lapped Balls (A2-A4) Using Abundant Slurry

Partially Polished (A2)

Partially Polished (A3)

Finish Polished (A4)

Comparative photographs of the partially polished and finished A(A2-A4) and B(B2-B4) series balls are shown in Figure 12. It is clear from the polishing rate data that polishing proceeds by removing a greater amount of material from the higher spots and a smaller amount at the lower spots. The polishing of the high spots is particularly evident from the SEM micrographs of the B-series balls (Figure 13). Since the B-series balls are rougher initially, this is in agreement with the previous finding that a greater diameter reduction is required to produce the B4 balls of finished quality comparable to the A4 balls.

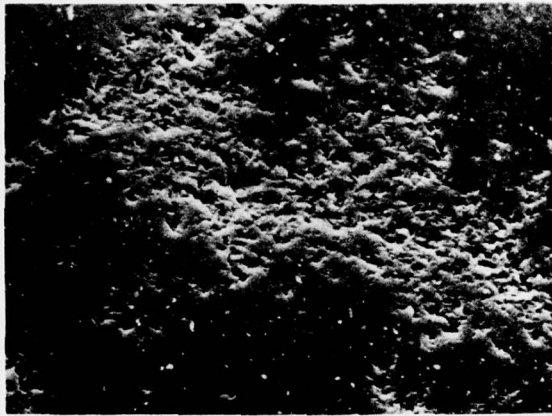
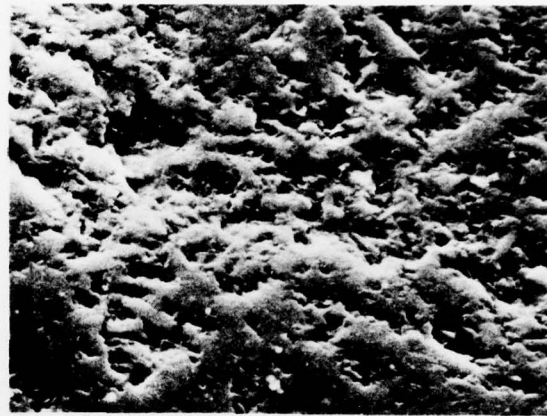
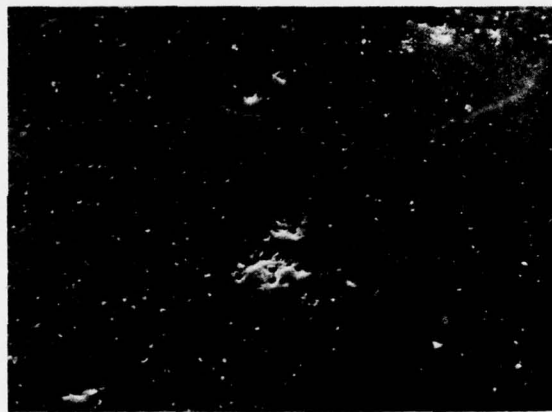
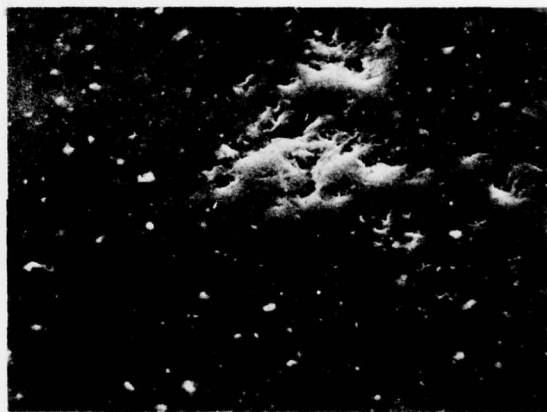
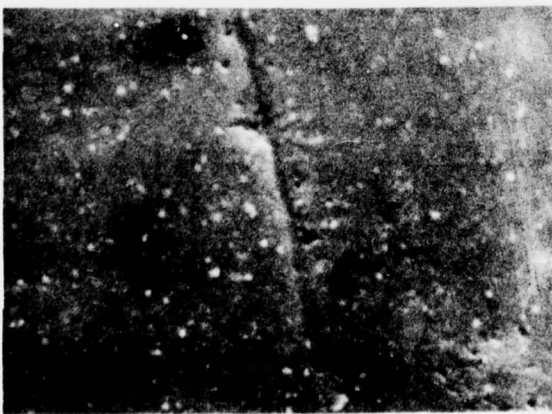
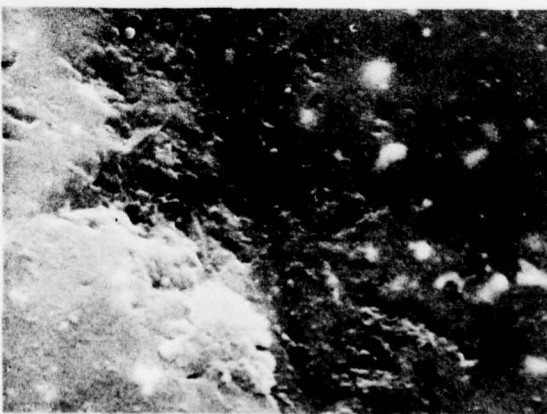
Figure 13. Surface Topography of Polished SiC Rough Lapped Balls (B2 - B4) Using Abundant Slurry.

Partially Polished (B2)

Partially Polished (B3)

Finish Polished (B4)
